AN EVALUATION OF  
BLIGHT CONDITIONS REPORT

PREPARED FOR  
THE CITY OF BREMERTON.

BY  
WILLIAM B. REEMS  
C.C.I.M., C.R.B., C.R.S.  
SENIOR CERTIFIED APPRAISER

Re: Blight Evaluation

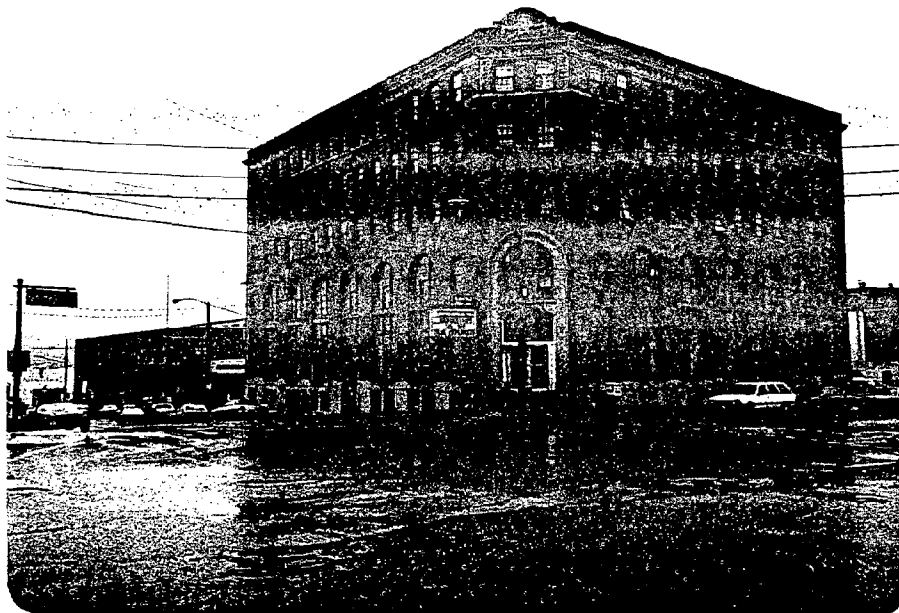
MAP REFERENCE NUMBER 1 (CONTINUED)

view looking southeast from opposite side of  
the intersection of Washington and 1st St.

CONDITION deteriorated, cracks in foundation, approximately  
5 off street parking stalls, is functionally obsolete.

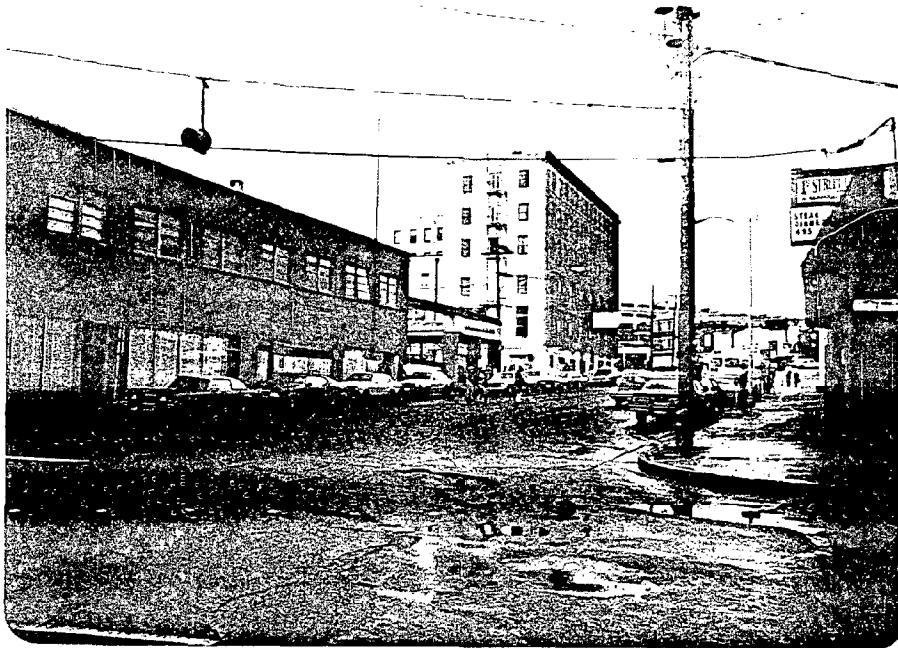
view looking at east side of building from  
east end of 1st St.

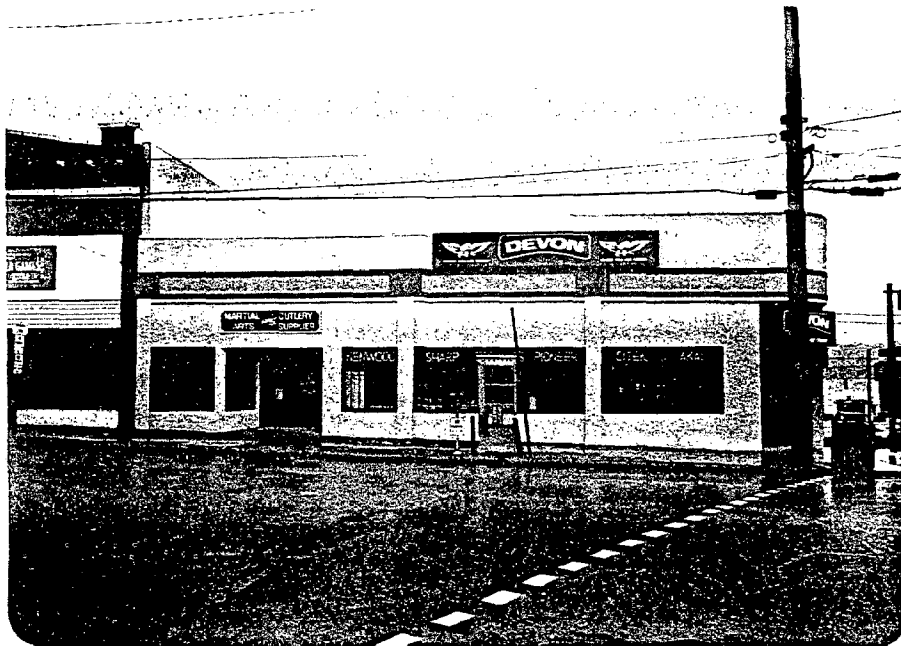
MAP REFERENCE NUMBER - 2 (CONTINUED)

view looking east at subject site

CONDITION remodeling just completed has upgraded  
building to modern standard. No off street parking on  
site and 100% building coverage of site.

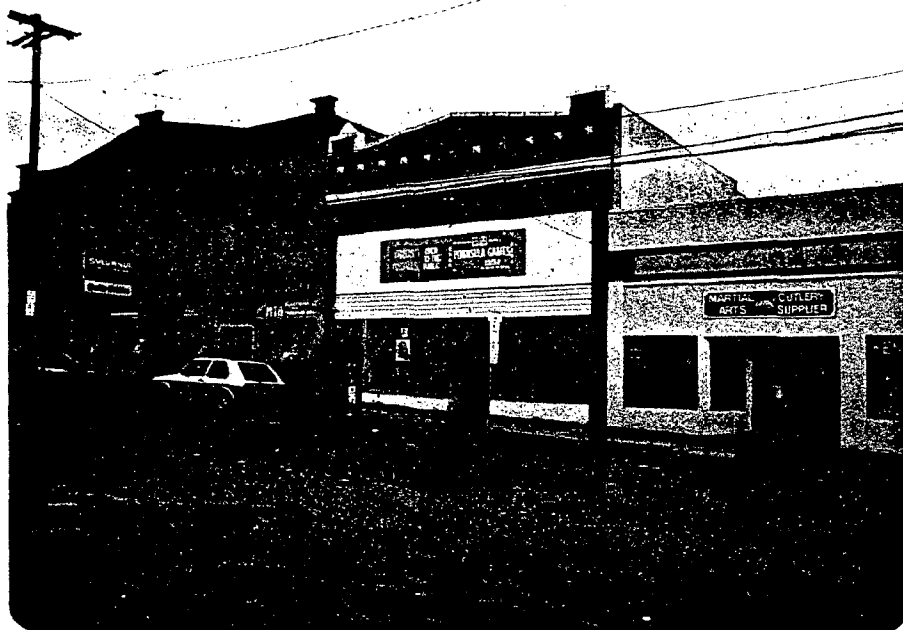
MAP REFERENCE NUMBER 3 (CONTINUED)

view looking east at subject

CONDITION recent facelift of structure, functionally  
obsolete, no off street parking, 100% building coverage  
of land.

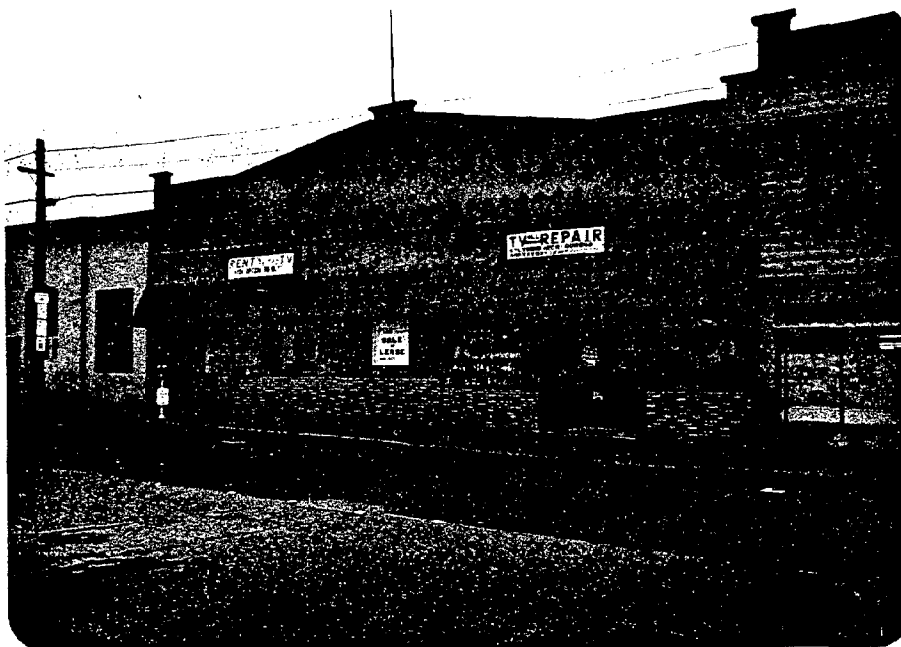
MAP REFERENCE NUMBER 4 (CONTINUED)

view looking east - northern portion  
of building.

CONDITION fair, exterior front has been remodeled,  
overall building is functionally obsolete, no off street  
parking at site.

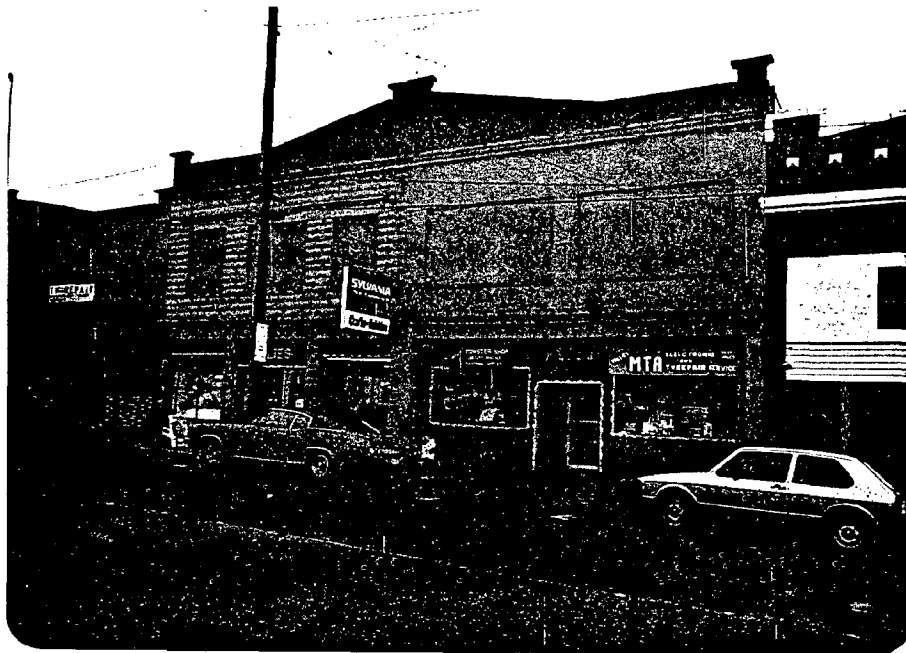
view of southerly building - looking east

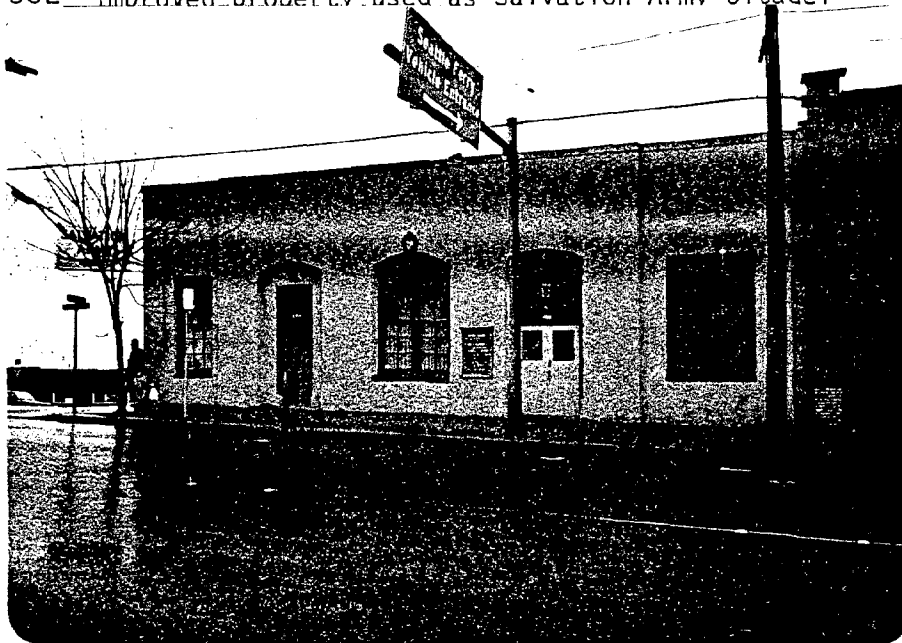
MAP REFERENCE NUMBER 5 (CONTINUED)

view looking northeast at subject

CONDITION Note is made of foundation cracks and overall  
exhibition of 70 year old age. Fair exterior appearance.  
No inspection made of the interior of the building.

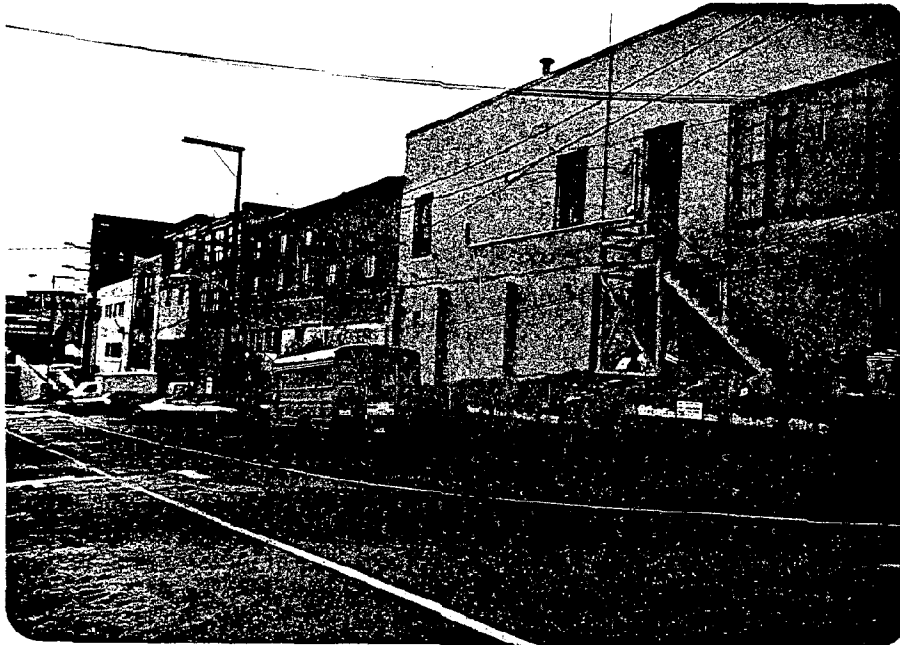
view of the east side of the building

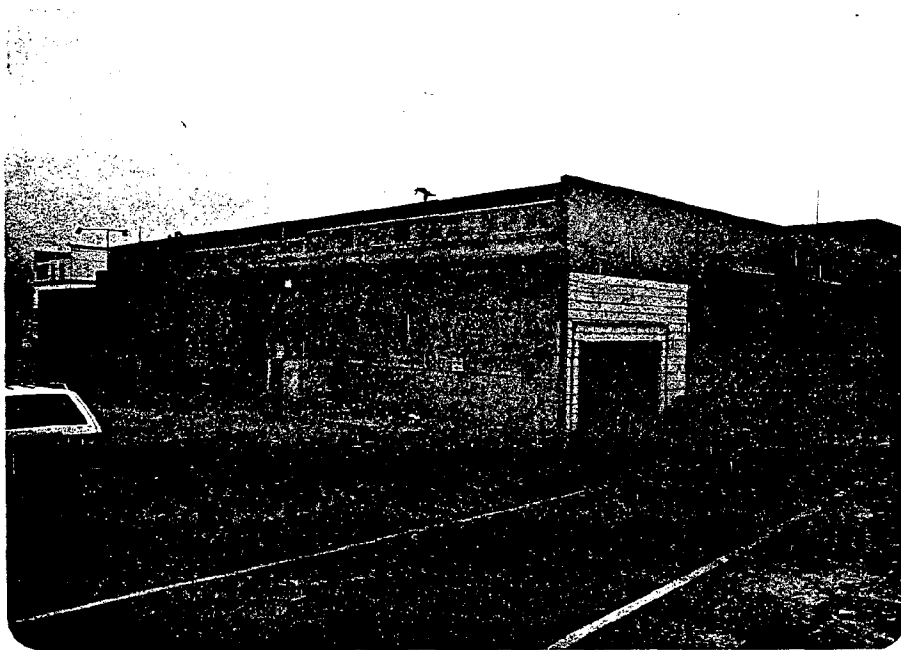
CONDITION Average condition, off street parking with  
access from the northwest corner of the building.

view of northwest corner of bldg.

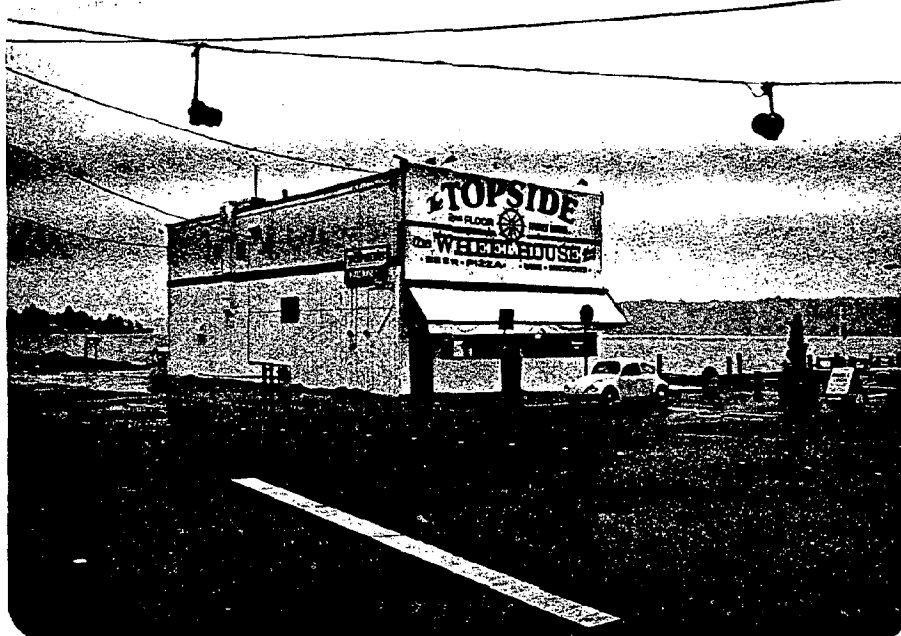
view of site looking northeast

CONDITION average to fair condition, remodeling recently  
to accomodate present business.

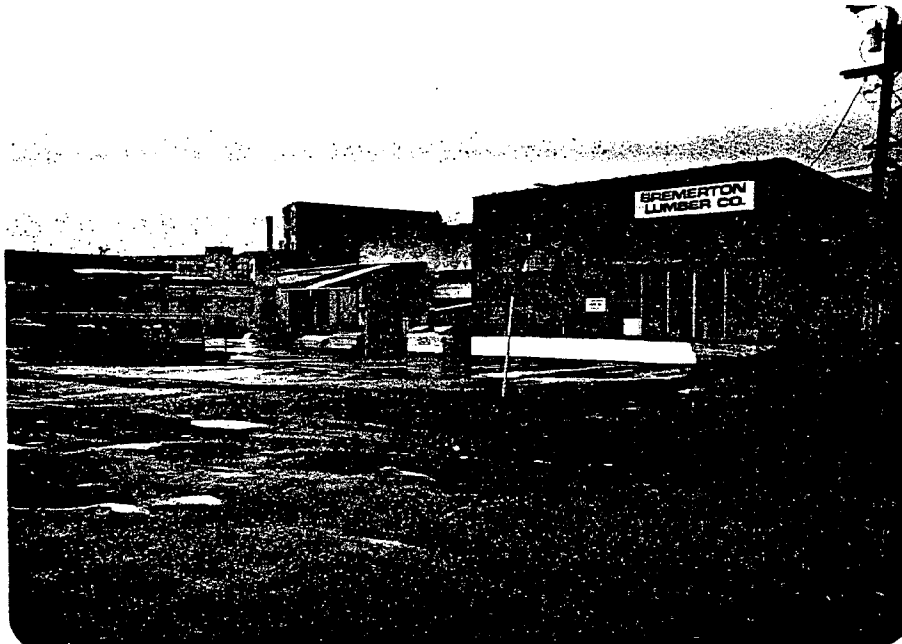
MAP REFERENCE NUMBER 54 (CONTINUED)

view looking southwest at subject

CONDITION Fair condition with signs of physical deterioration  
and functional obsolescence.

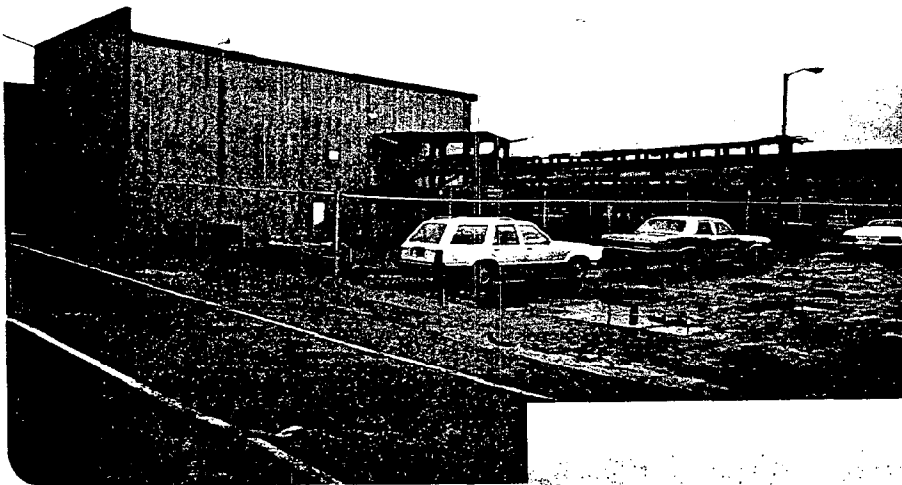
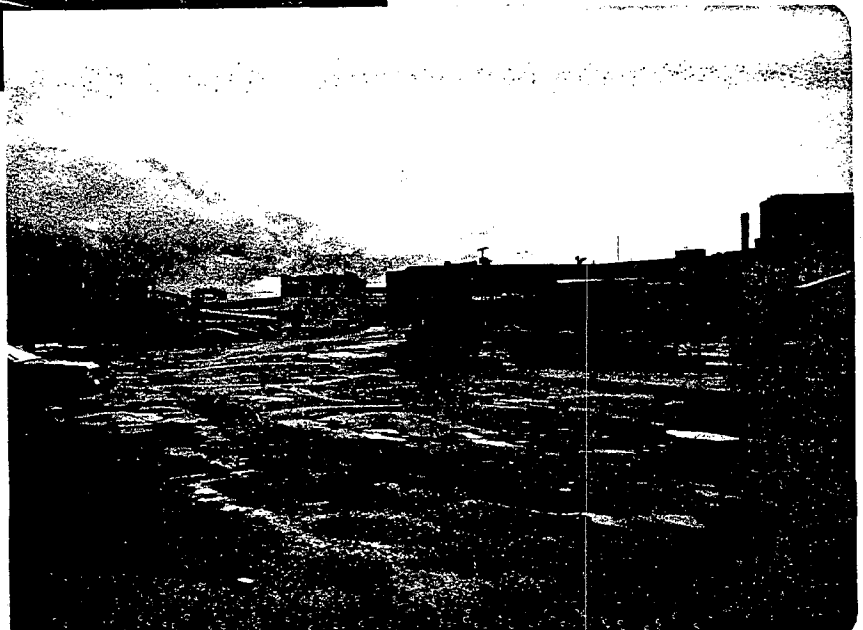
view looking  
east from alley

view looking south  
from unnamed road  
at intersection with  
2nd St.

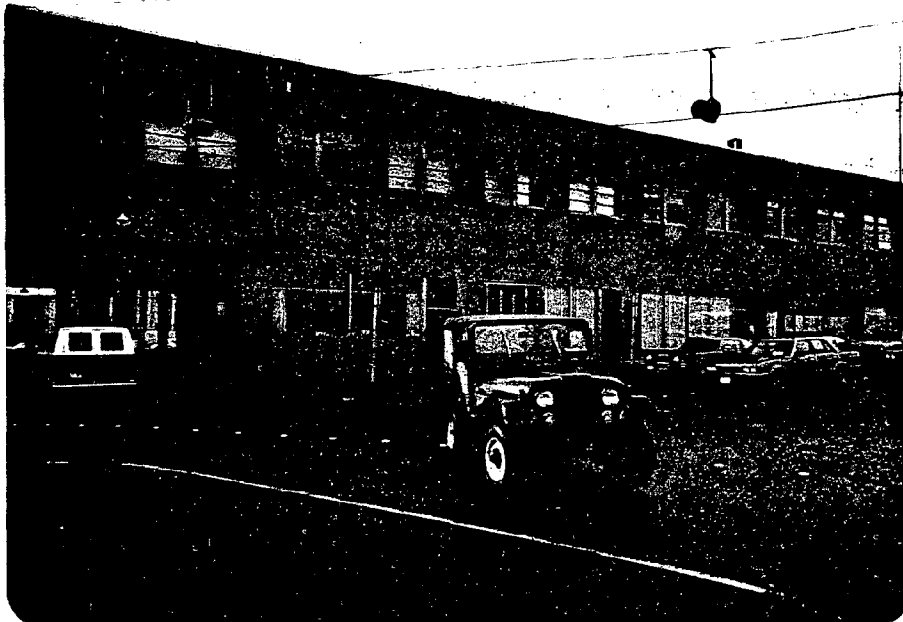
MAP REFERENCE NUMBER 55 (CONTINUED)

view of the north side of subject building

CONDITION Fair condition showing much physical deterioration  
and functional obsolescence.

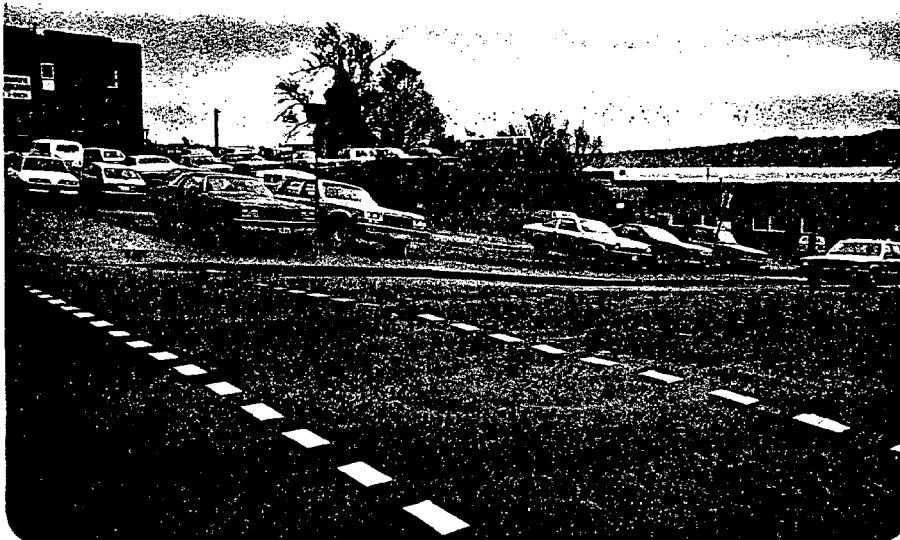
USE Present use is self service parking lot  
with gravel and deteriorated asphalt surface.

view looking northeast

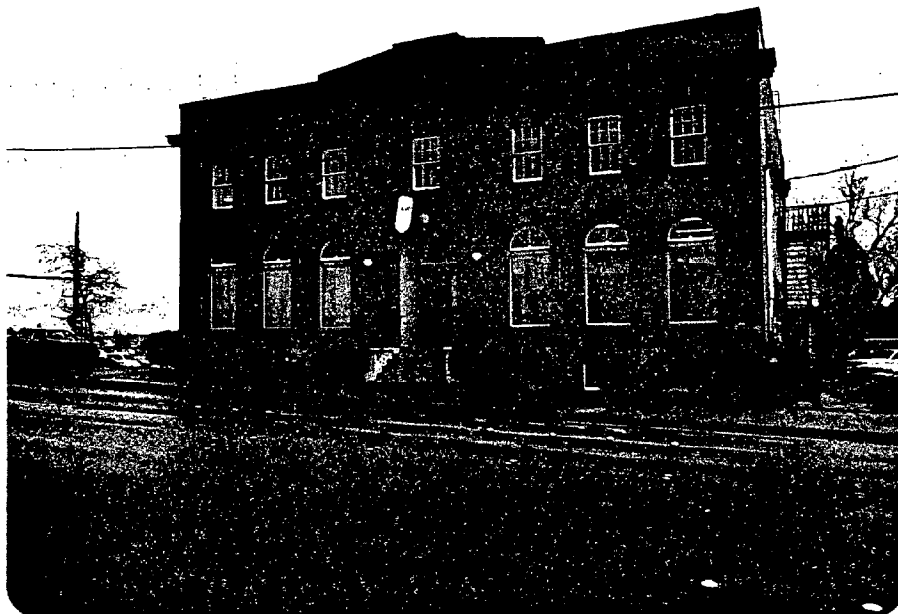
MAP REFERENCE NUMBER 9 (CONTINUED)

view looking east at subject

CONDITION Functional obsolescence has been partially cured by recent remodeling, shell of building shows signs of 1920 vintage, limited off street parking with narrow access.

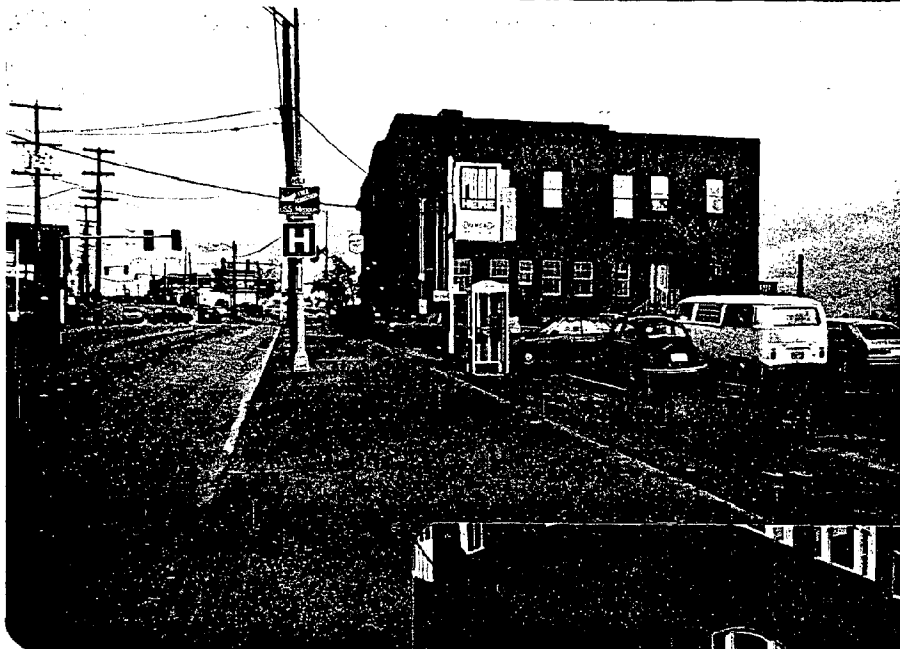
South wall looking north

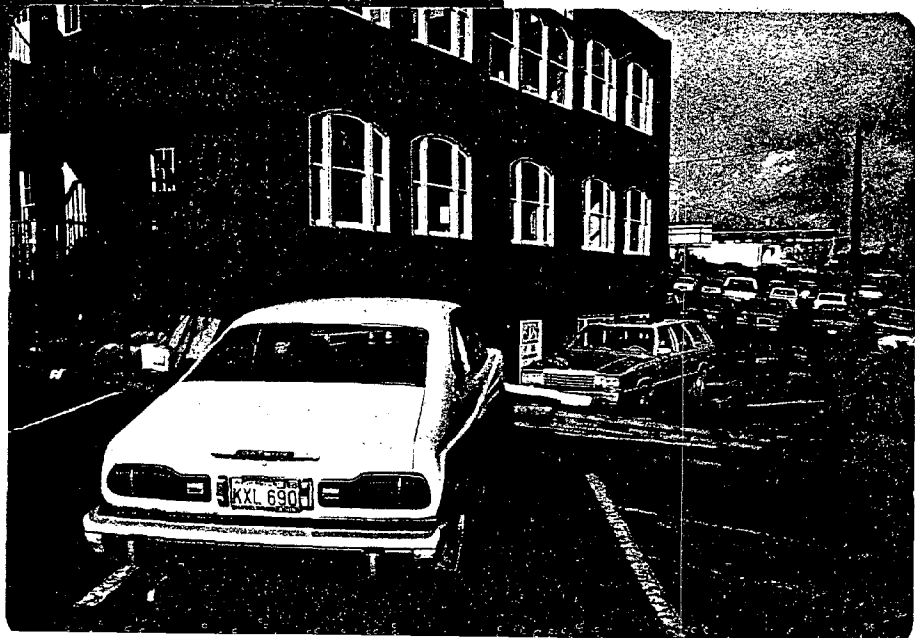
view of east side,  
parking adjacent

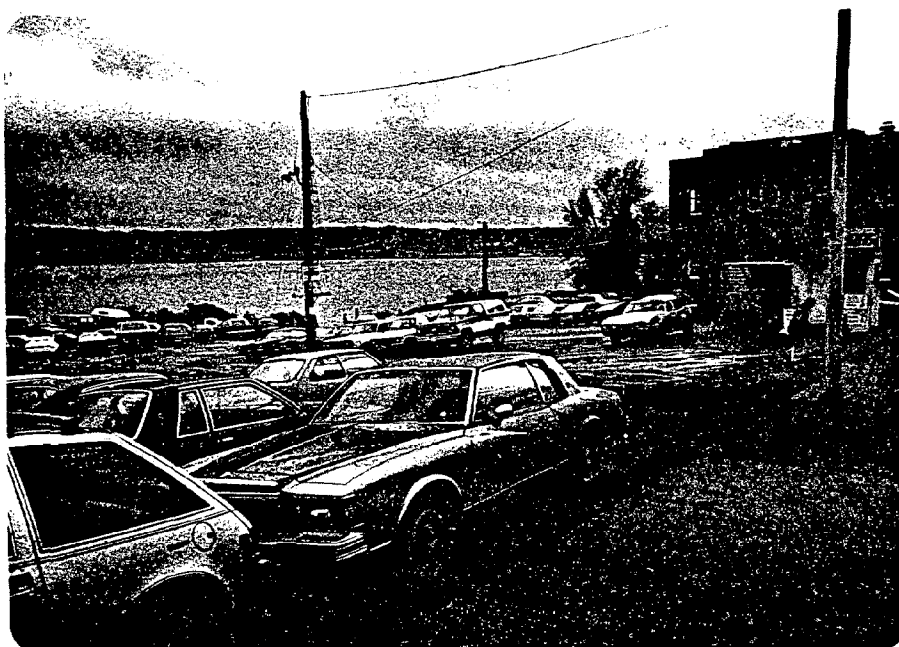
USE Attended parking lot, no numbered spaces, deteriorated  
asphalt and gravel surface, undeterminable capacity.

view looking southeast

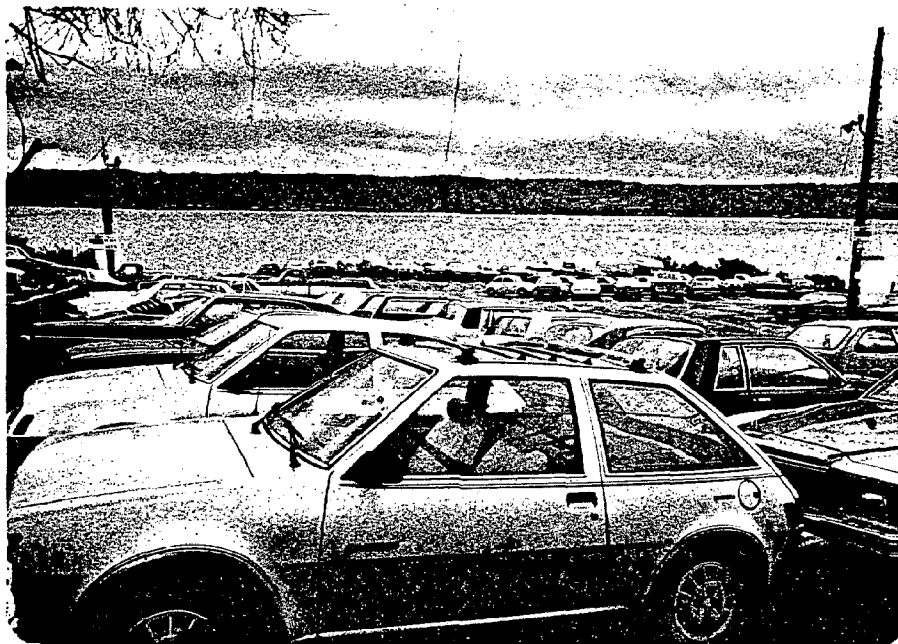
USE Attended parking lot, no numbered spaces, deteriorated  
asphalt and gravel surface, used in conjunction with  
reference parcel 10, undeterminable capacity.

view looking east across subject

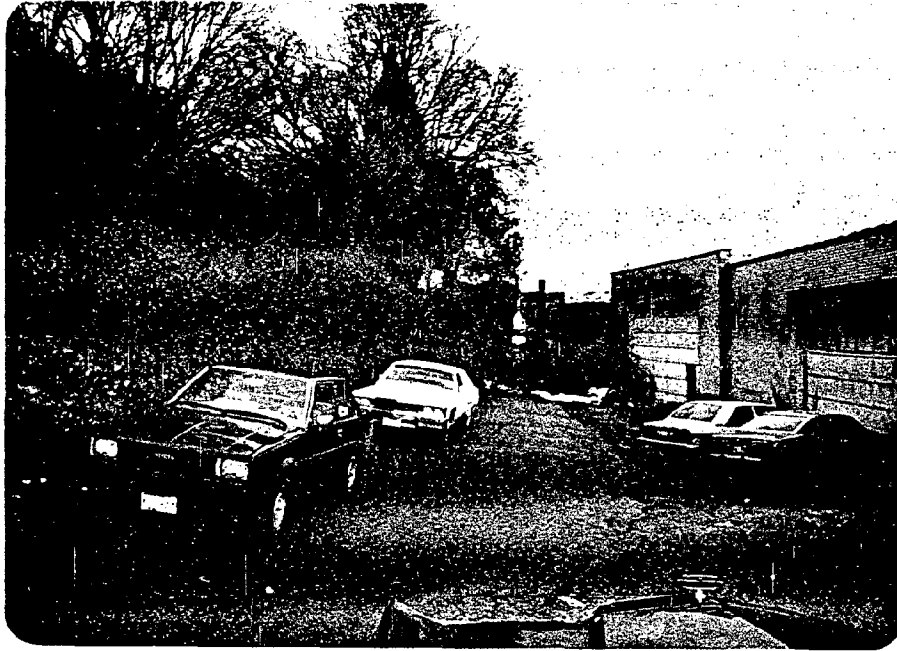
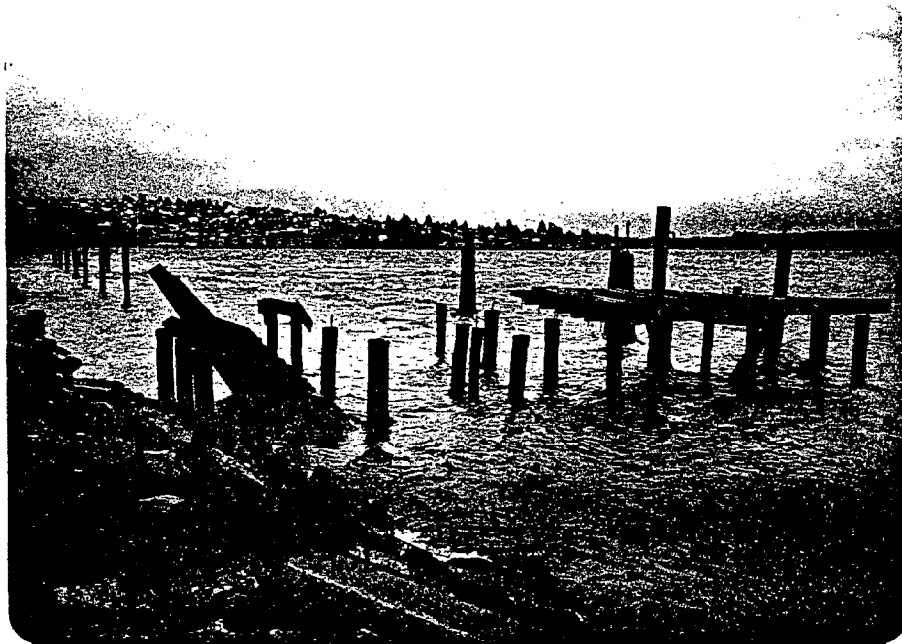
MAP REFERENCE NUMBER 20 (CONTINUED)

CONDITION fair, several signs of physical deterioration  
and functional obsolescence.

view of the easterly side of the structure  
(note access to parking lot on parcels 10  
and 11 at the right of photo)

view of the westerly side of the building showing  
access to warehouse doors and embankment to the west.

view of the remains of saltwater dock on  
easterly boundry of property.

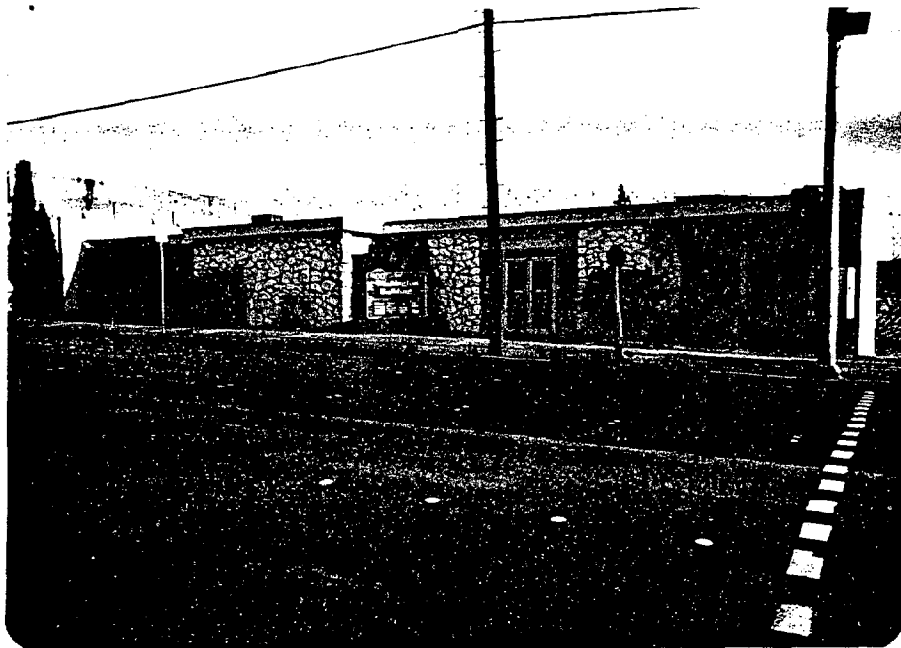
MAP REFERENCE NUMBER 15 (CONTINUED)

view looking east at subject

CONDITION average physical condition, has adequate off  
street parking but with difficult access (due to steepness)  
onto Washington Ave.

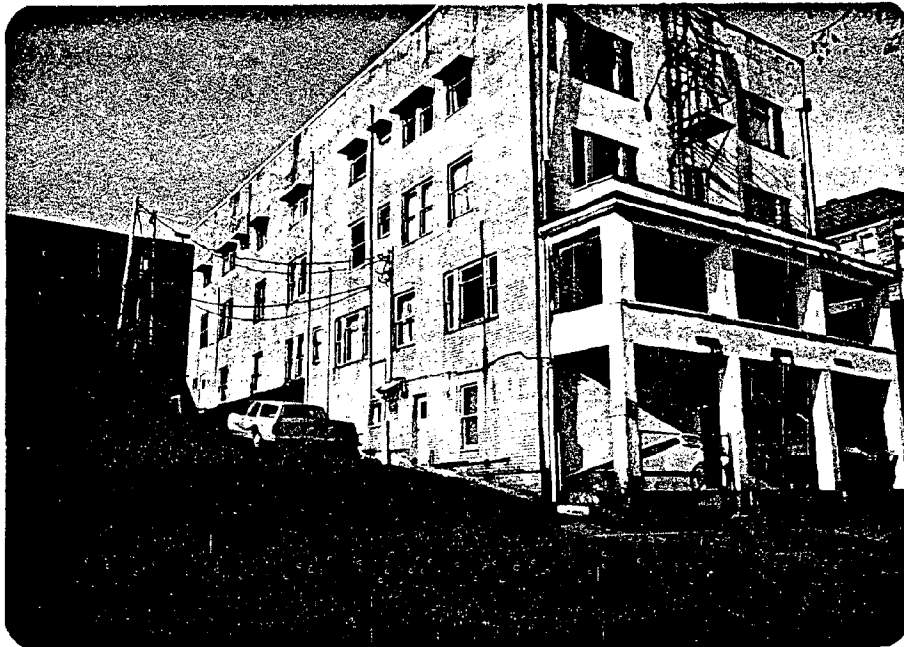
TOPOGRAPHY Vertical drop through building site and  
approximately 35 feet to beach. Bank erosion noted.

CONDITION overall condition is fair, much obsolescence  
is noted as well as physical deterioration.

view of east side of bldg. looking northwest

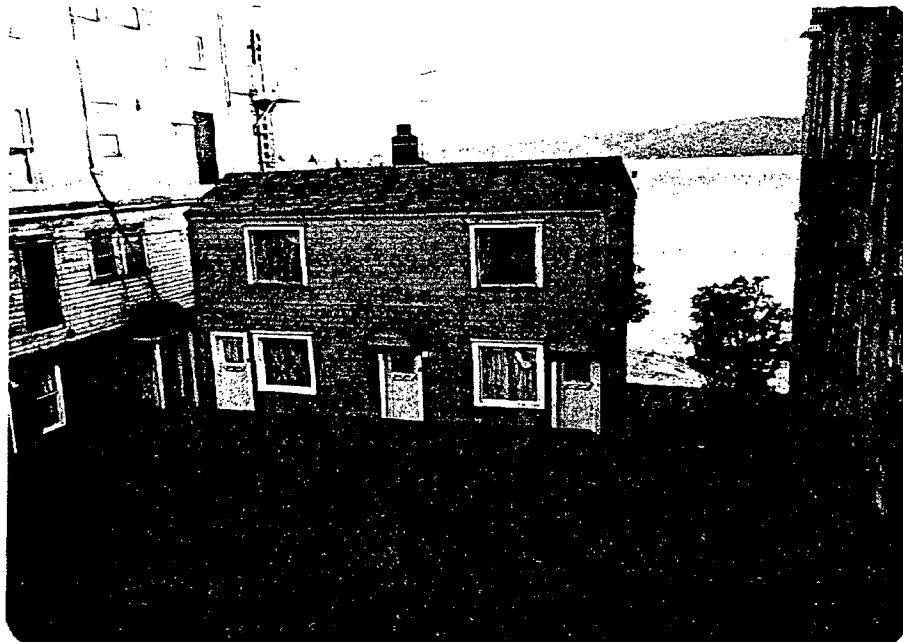
MAP REFERENCE NUMBER 17 (CONTINUED)

view looking east from Washington Ave.

CONDITION fair condition, functional obsolescence  
with some physical deterioration. No off street parking.

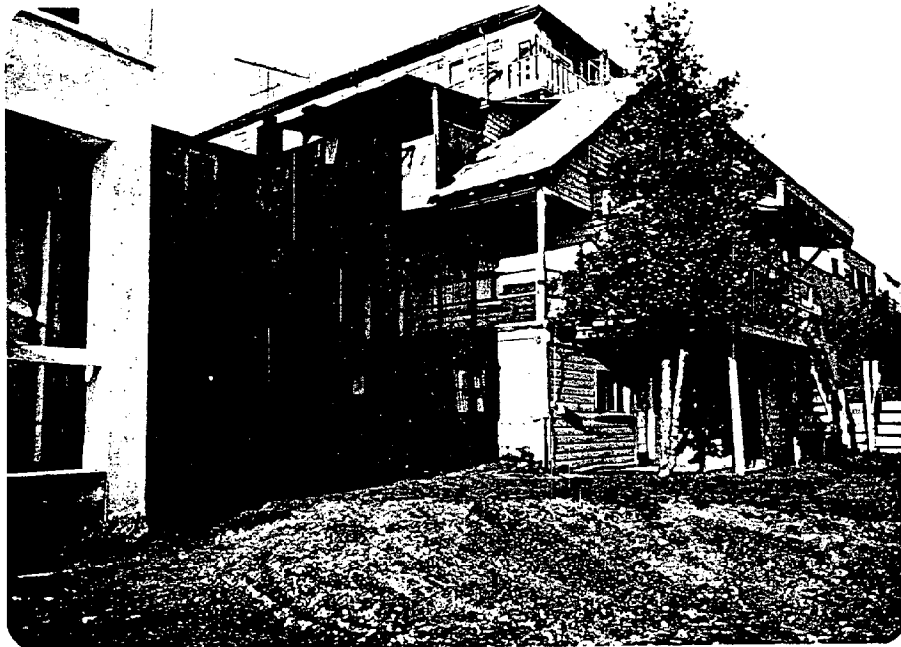
view of east side of unit

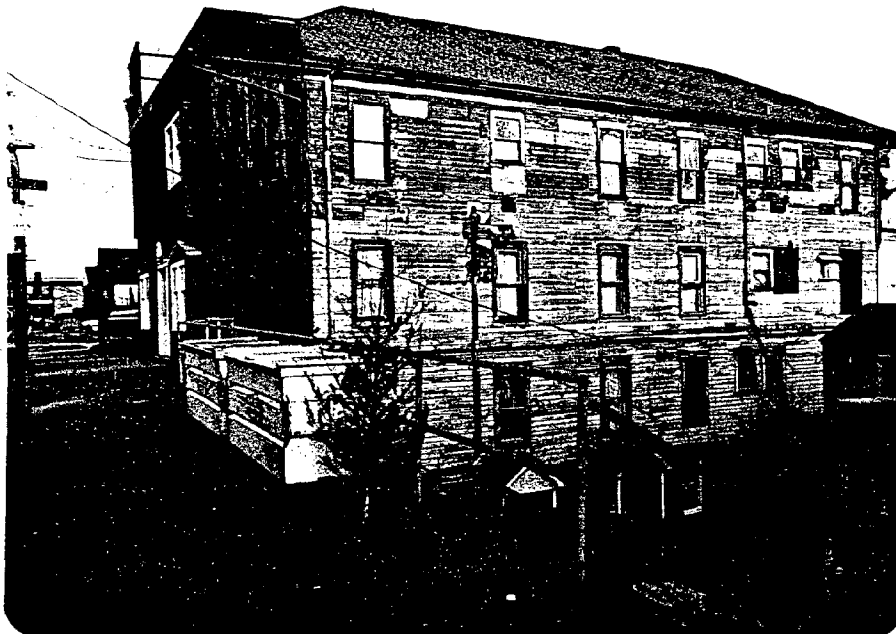
MAP REFERENCE NUMBER 18 (CONTINUED)

view looking northeast at subject

CONDITION Fair to poor condition with a substantial  
amount of physical deterioration and functional obsolescence.

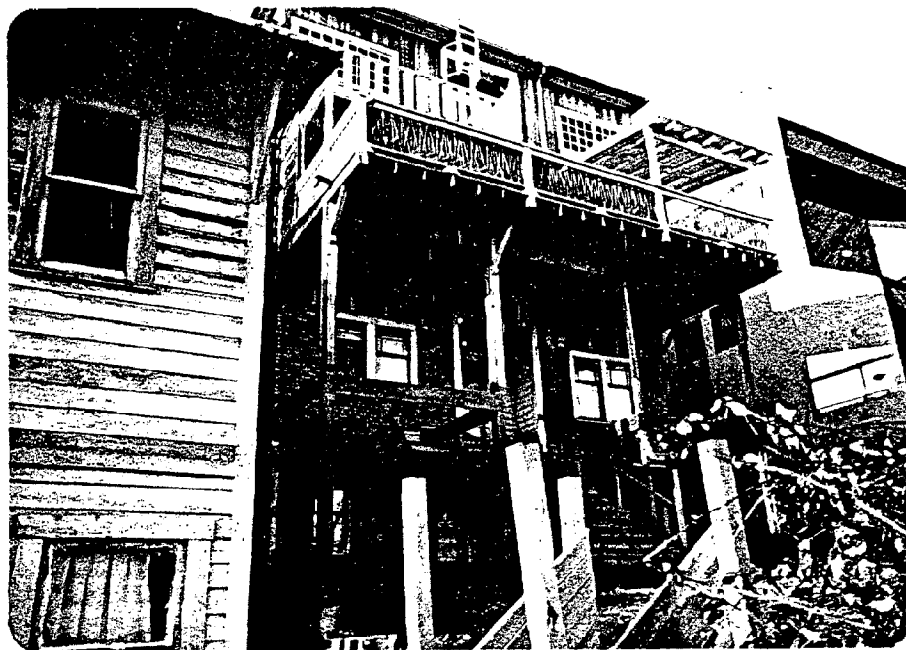
view of the east side looking northwest

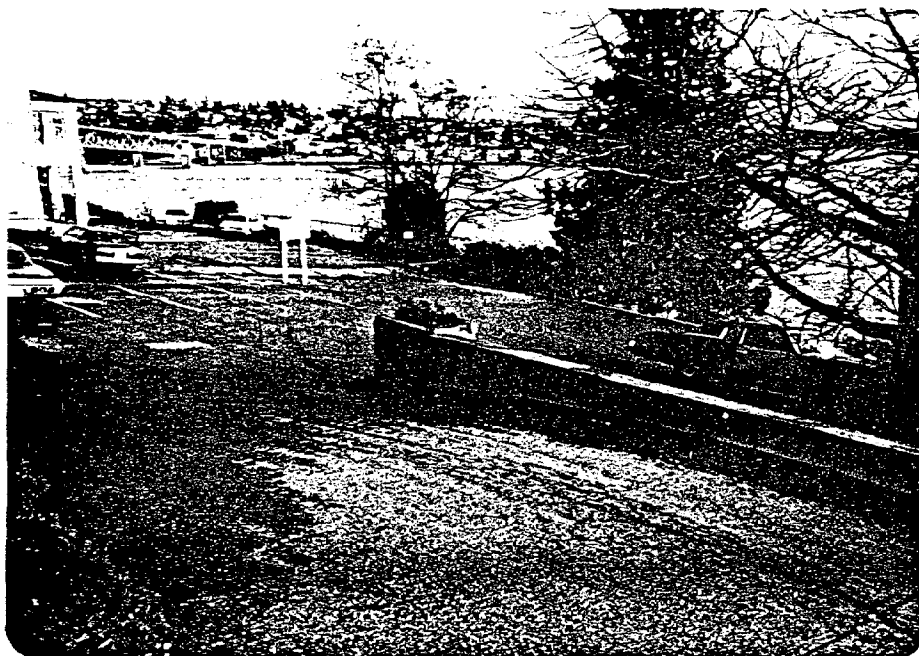
USE Presently used in conjunction with a professional office building on reference parcel 15. Improved for parking and has provision for storm water disposal to prevent eroding of the bank.

view looking northeast from southwest corner of  
the site

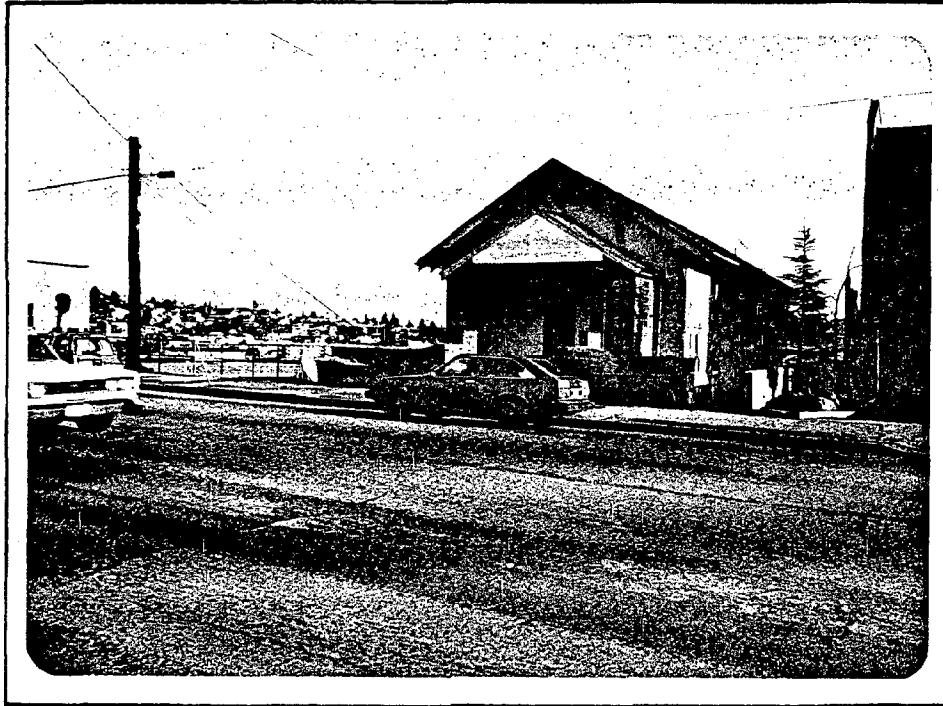
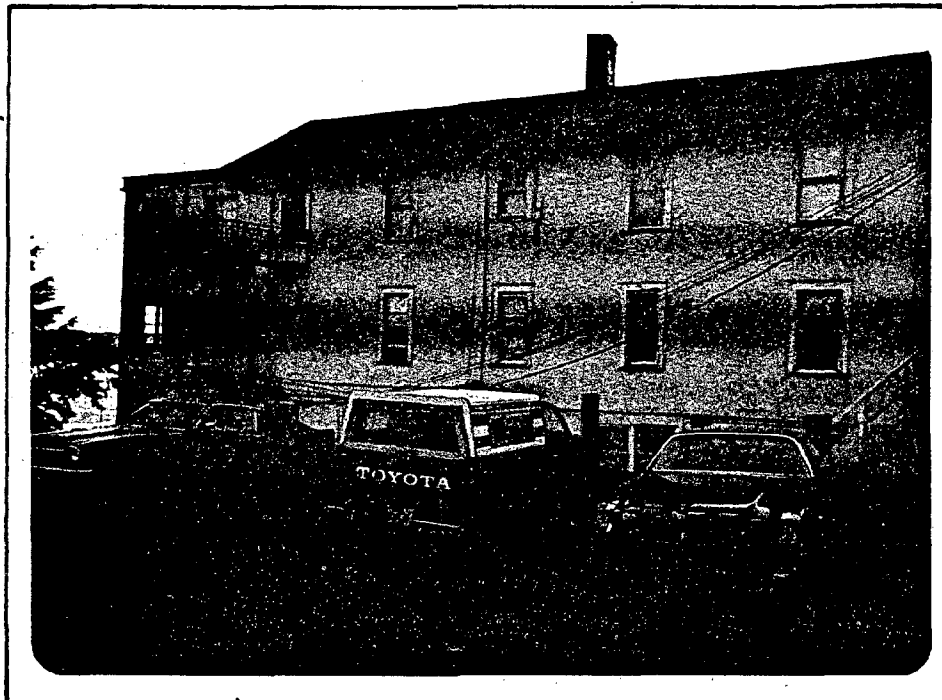
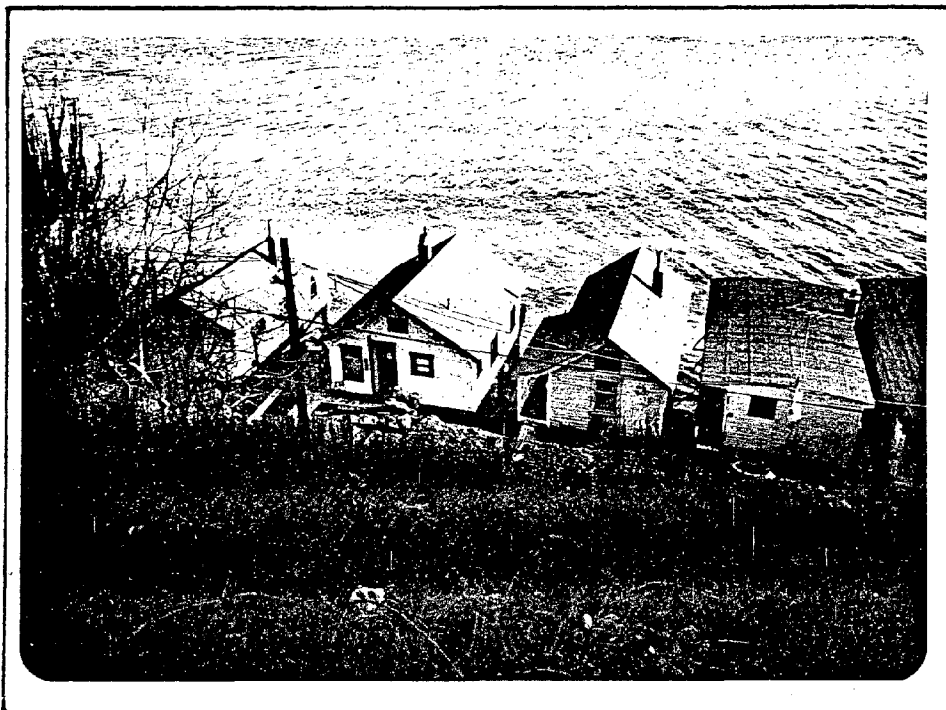
CONDITION mostly in deteriorated condition with substantial

516 Washington Ave - front view  
southern most building

view of 516 Washington from  
parking area below grade of Washington Ave.

Former retail sales outlet - now vacant  
located midway (north to south) at  
Washington Ave.

602 Washington Ave. - northern most  
multi family building fronts Washington Ave.

view looking east at beach  
houses - rental units

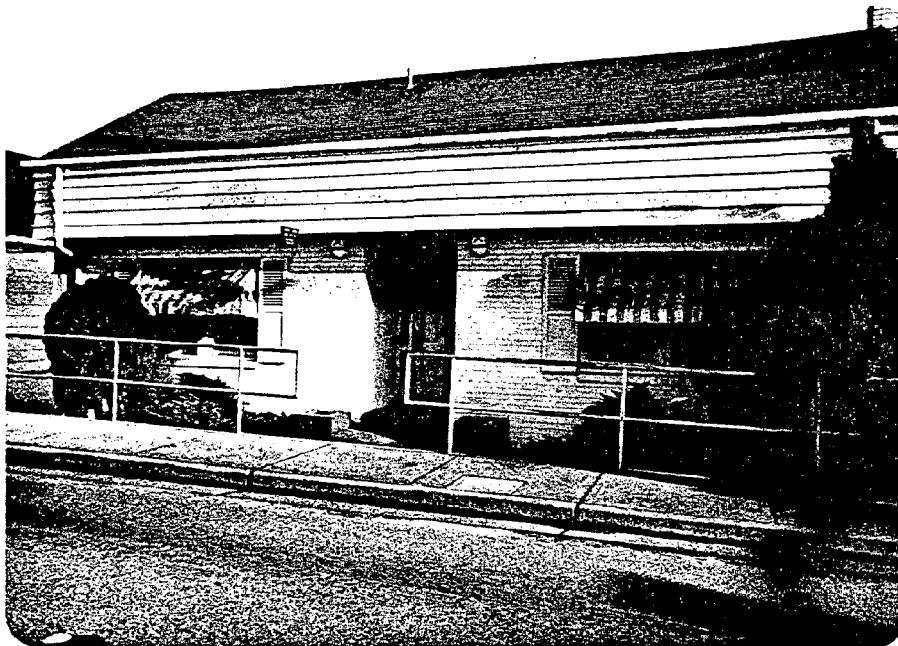
MAP REFERENCE NUMBER 29 (CONTINUED)

front view of 608 Washington Ave.

CONDITION average condition, functional obsolesence due to lack of off street parking to accomodate tenants.

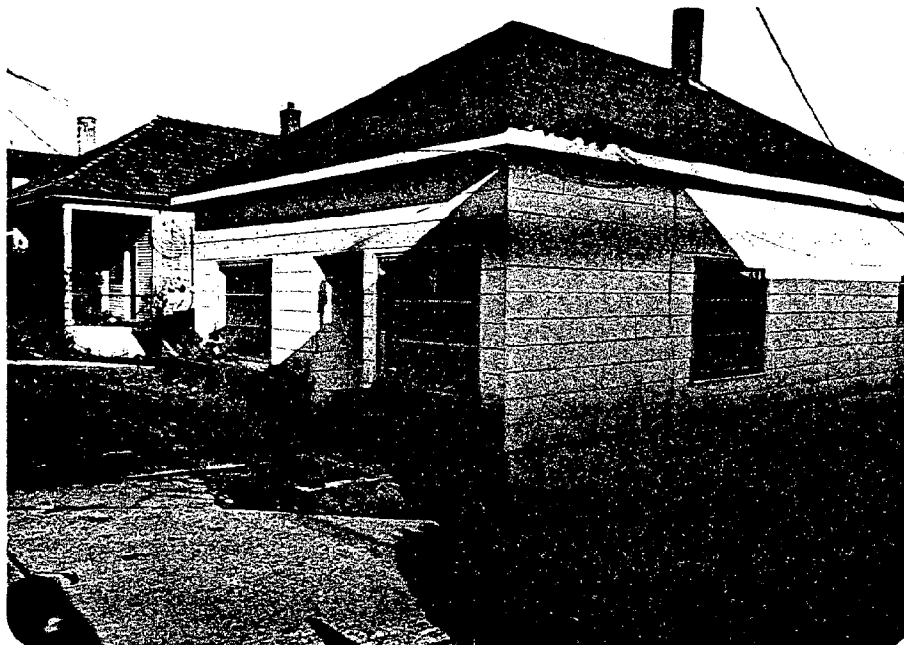
MAP REFERENCE NUMBER 30 (CONTINUED)

view of residence on Washington Ave.

CONDITION fair condition, little off street parking and some physical deterioration and functional obsolescence noted.

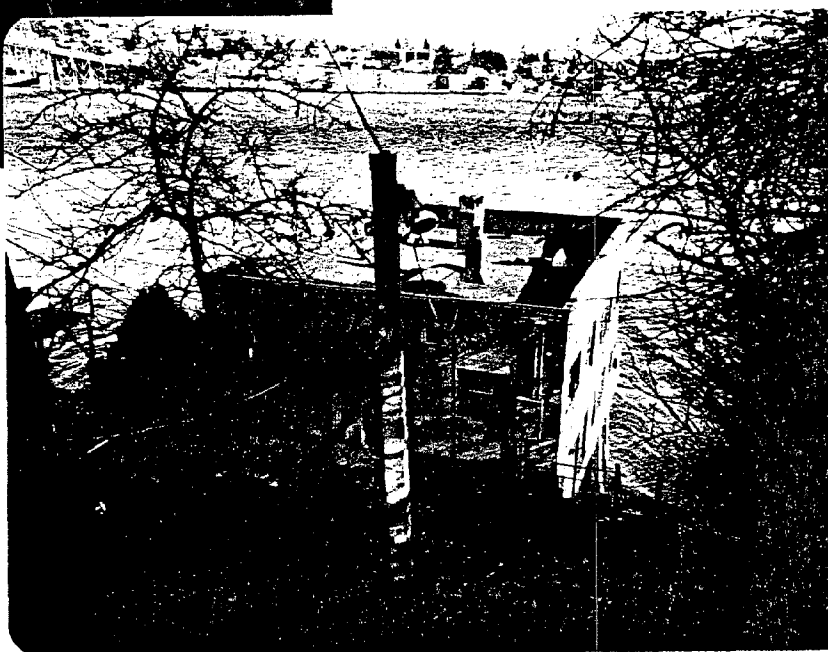
driveway to  
lower units-  
looking east.

residential unit  
located on beachfront

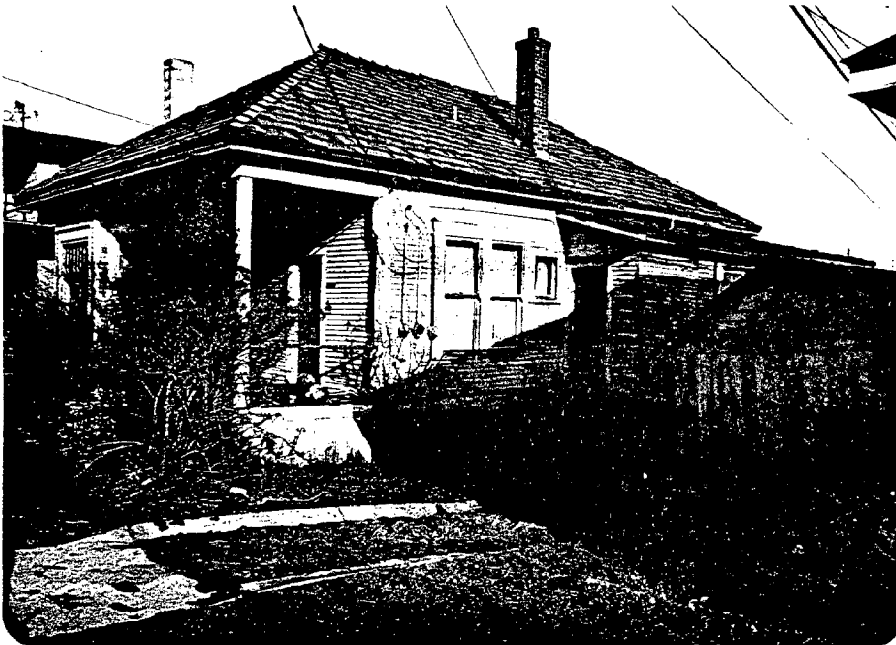
MAP REFERENCE NUMBER 31 (CONTINUED)

view of subject as it fronts Washington Ave.

CONDITION poor condition with much evidence of physical  
deterioration and functional obsolescence. New wood roof  
has recently been installed.

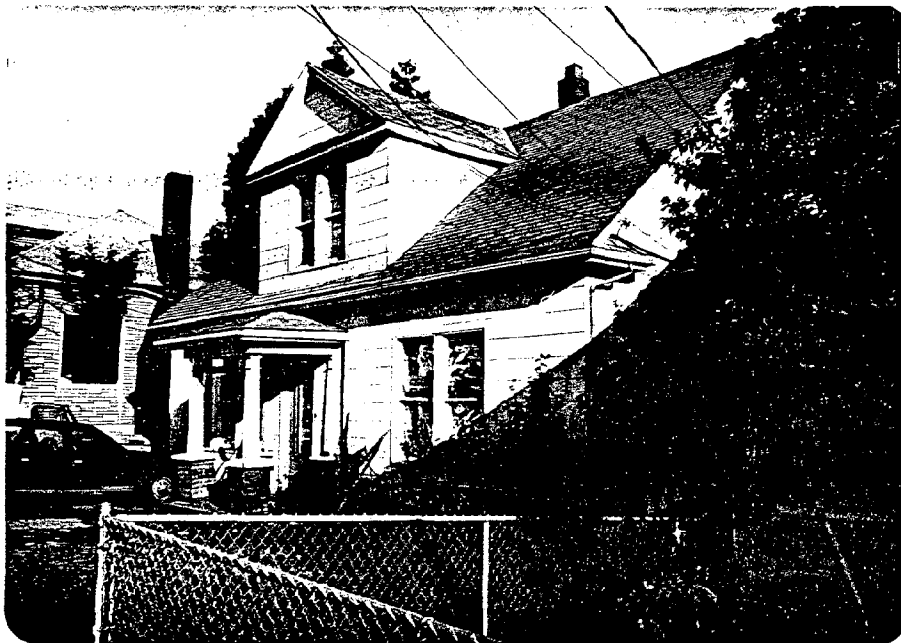
MAP REFERENCE NUMBER 34 (CONTINUED)

view of subject looking northeast along  
Washington Ave.

CONDITION Fair, shows signs of physical deterioration  
and functional obsolescence.
